Bushfire Mitigation Plan 2023-2024

AU-3008-OPS-PHA-EL-PLN-00001

11 April 2023

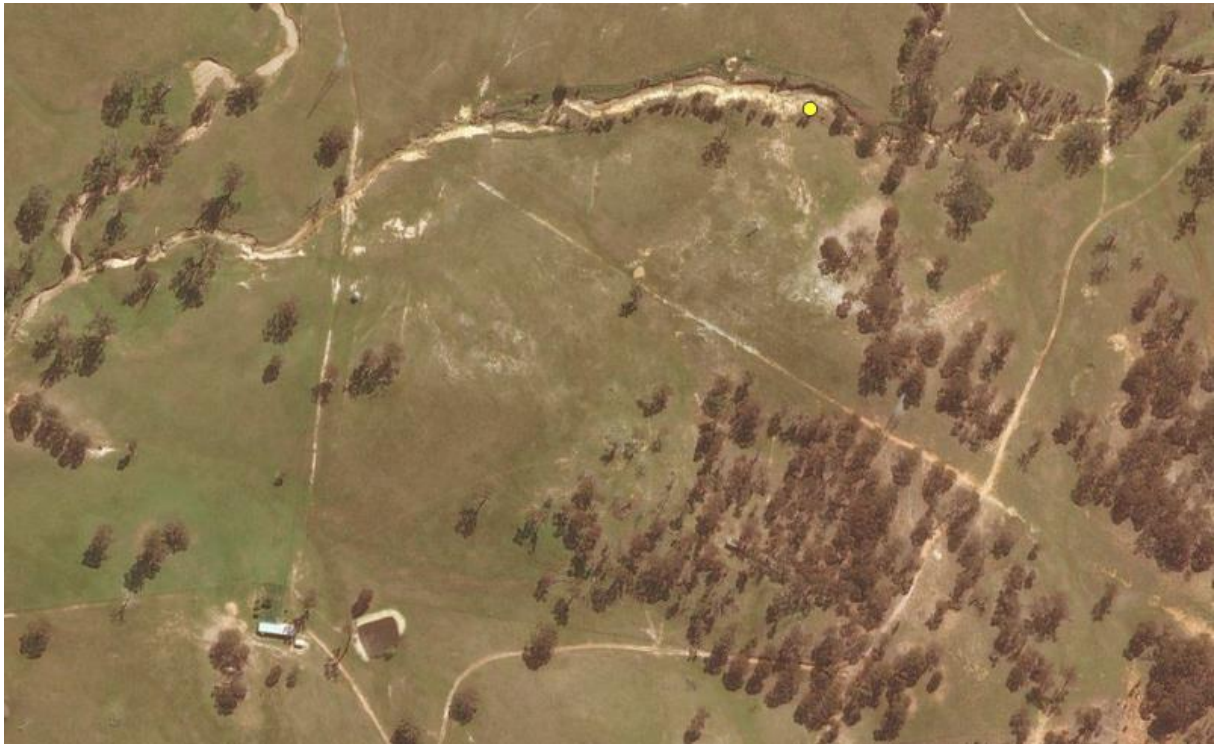
Map of Locations

Code	Description
55	Foliage in Contact or likely to Contact Conductor
56	Foliage currently inside the Clearance Space
2022	Foliage Predicted to grow into Clearance Space 2022
2023	Foliage Predicted to grow into Clearance Space 2023
2024	Foliage Predicted to grow into Clearance Space 2025
2025	Foliage Predicted to grow into Clearance Space 2025
VS	Foliage Predicted to grow into Clearance Space 2025 to 2010
NVS	Non-Vegetated Span
