Bushfire Mitigation Plan 2024-2025

AU-3008-OPS-PHA-EL-PLN-00001

Challicum Hills Pre Fire Season Inspection 2024

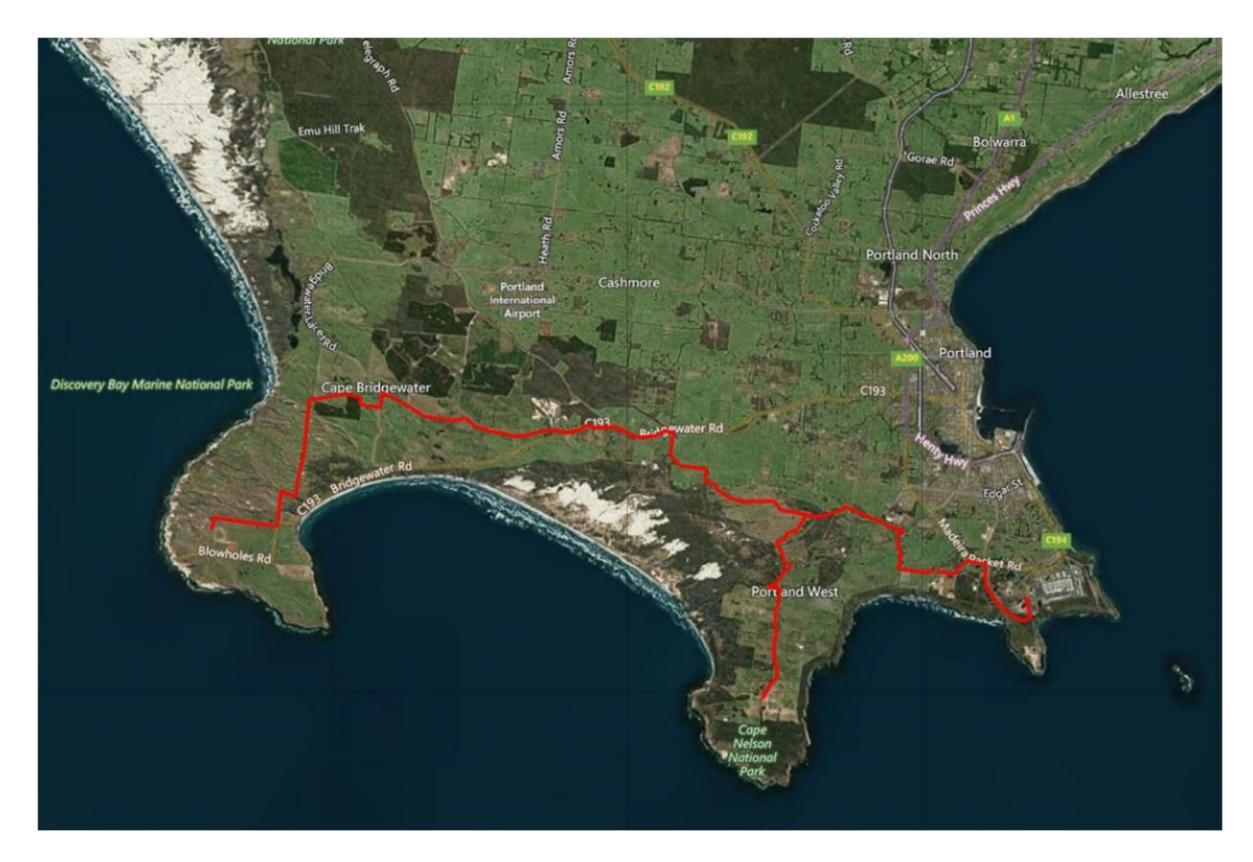
Appendix A. Portland Wind Farm Overhead Line – Site Layout (HBRA Classified)

Кеу	Description
0	Wind turbine generator
2	Overhead power line
12	Overhead power line Challicum Hills and Crowlands
a.	Underground cable
8	Poles owned by Pacific Hydro
8	Poles owned and maintained by DNSP (Powercor)

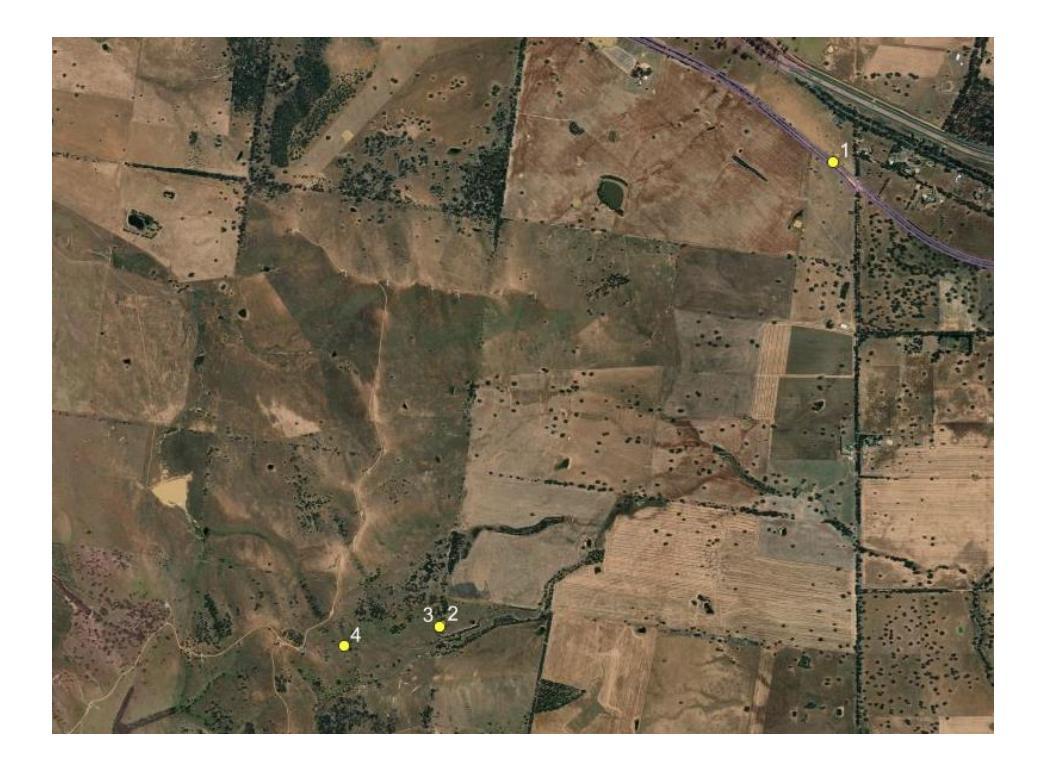
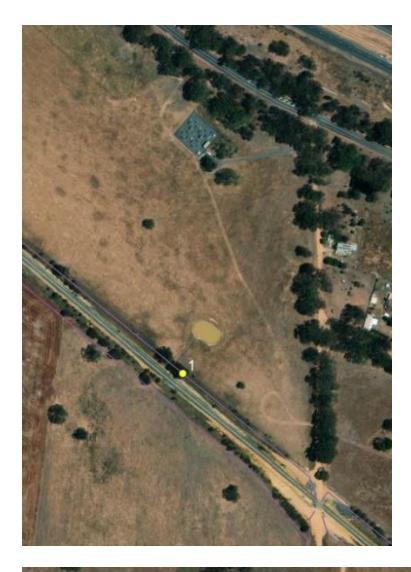
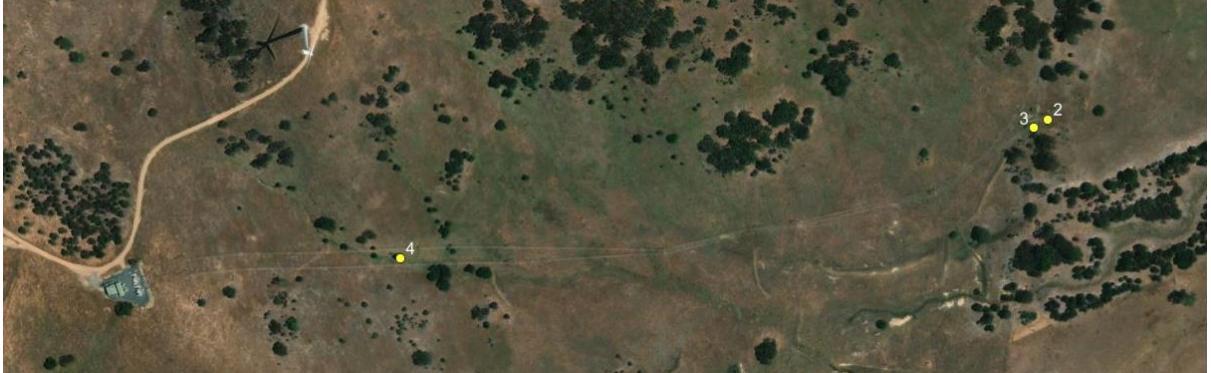
The 66kV line was inspected on the 6th August 2024. All spans were inspected, and the codes have been updated to reflect their status. The data for these lines is within Appendix 1

There is 1 span that is coded "2025" that will require actioning before the 2024/2025 fire period is declared 3 spans have been coded 2026 which are regrowth from previous removals and should be actioned now whilst small and more economic to remove all other Spans will maintain the required clearance throughout the upcoming 2024/2025 fire season. details are listed in the tables below

Span	Work Required	Comments
Pole 3-4	2 trims	New Growth
Pole 34-35	6 removals	Regrowth from previous removals
Pole 35-36	25 Removals	Regrowth from previous removals
Pole 40B-41B	3 removals	New growth removal recommend to prevent issues in the
		future

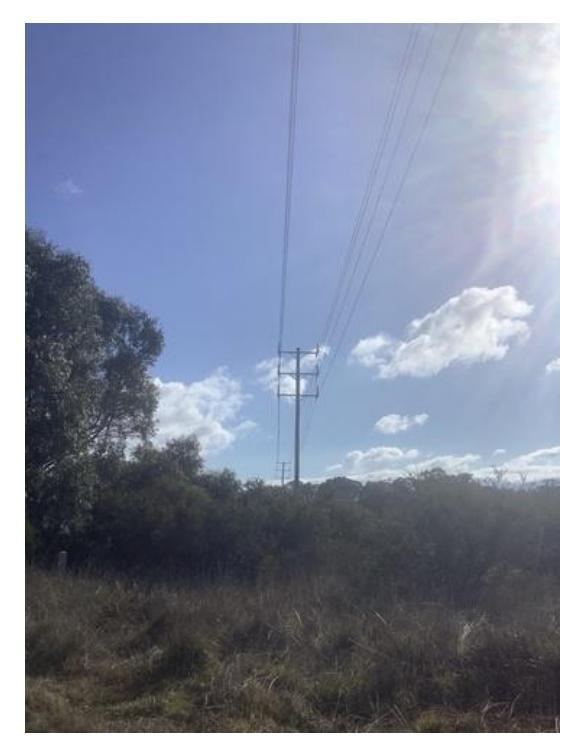
Photo 1

Challicum Hills Location 4				
Pole Number	40B			
Land Owner	Private			
Photo 5				
Trims				
Removals	3			
Species	Acacia			
Equipment Required	Ground Crew			
Comments	2025

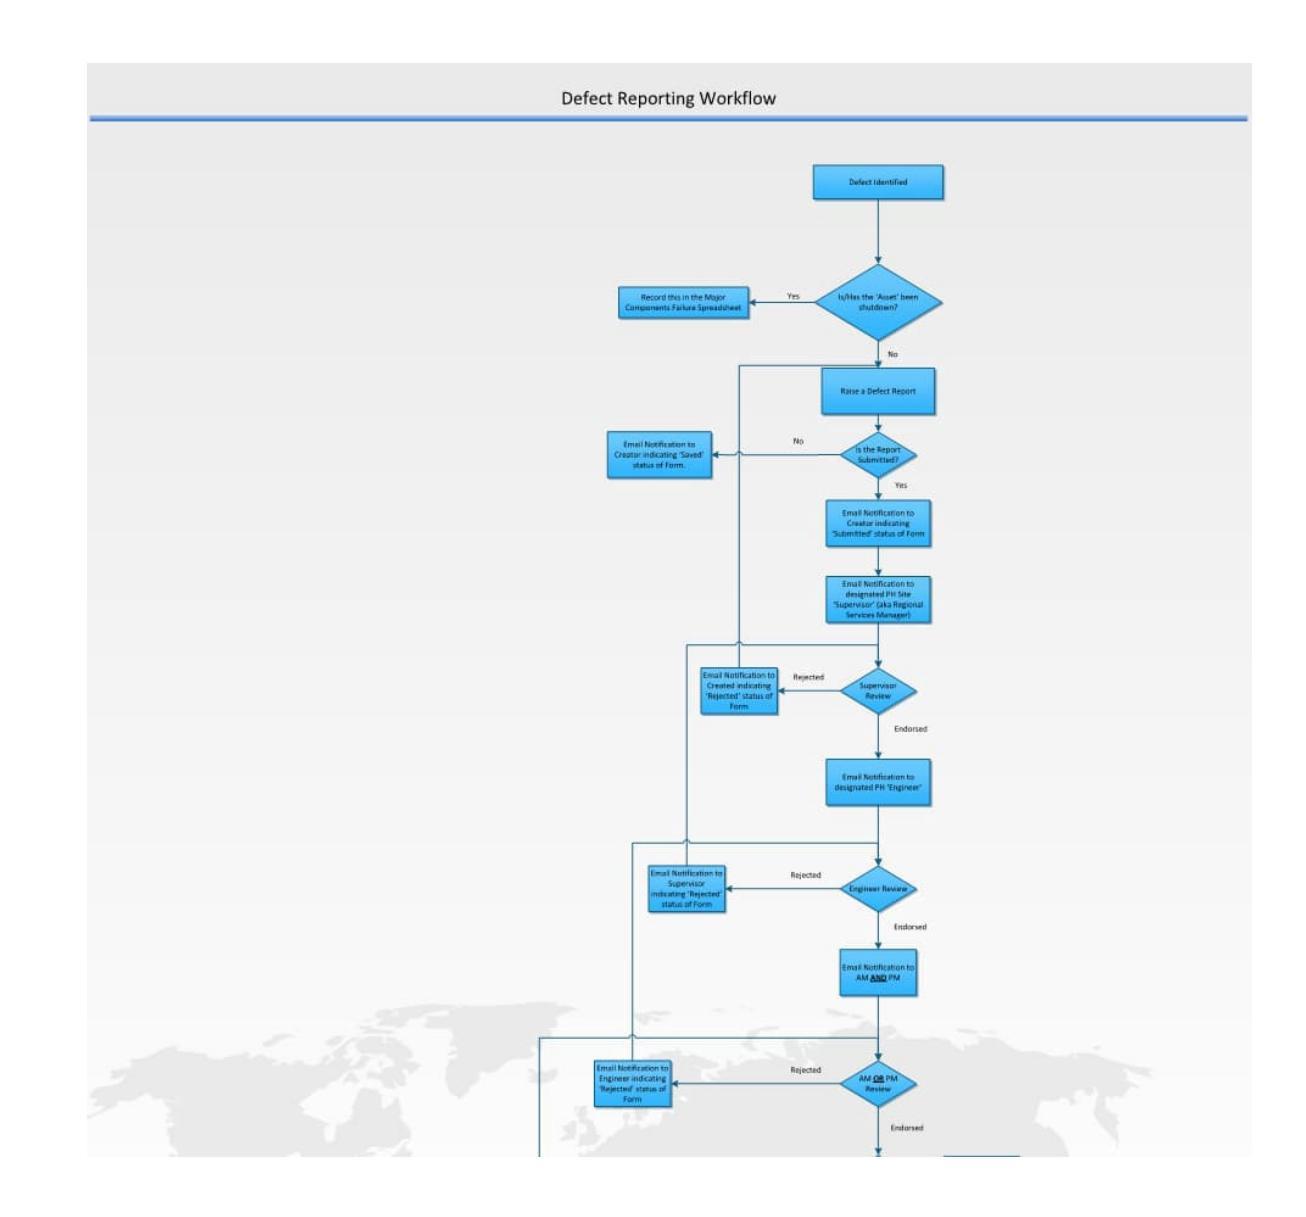
Appendix B – Defect Reporting Workflow

The basic steps in the Pacific Blue initiated Defect Reporting process are shown below. It is structured to ensure a staged approval process which is graphically represented in Appendix B.
