# Electric Line Clearance Management Plan 2025-2026

**AU-1000-OPS-PLN-00005**

10 July 2025

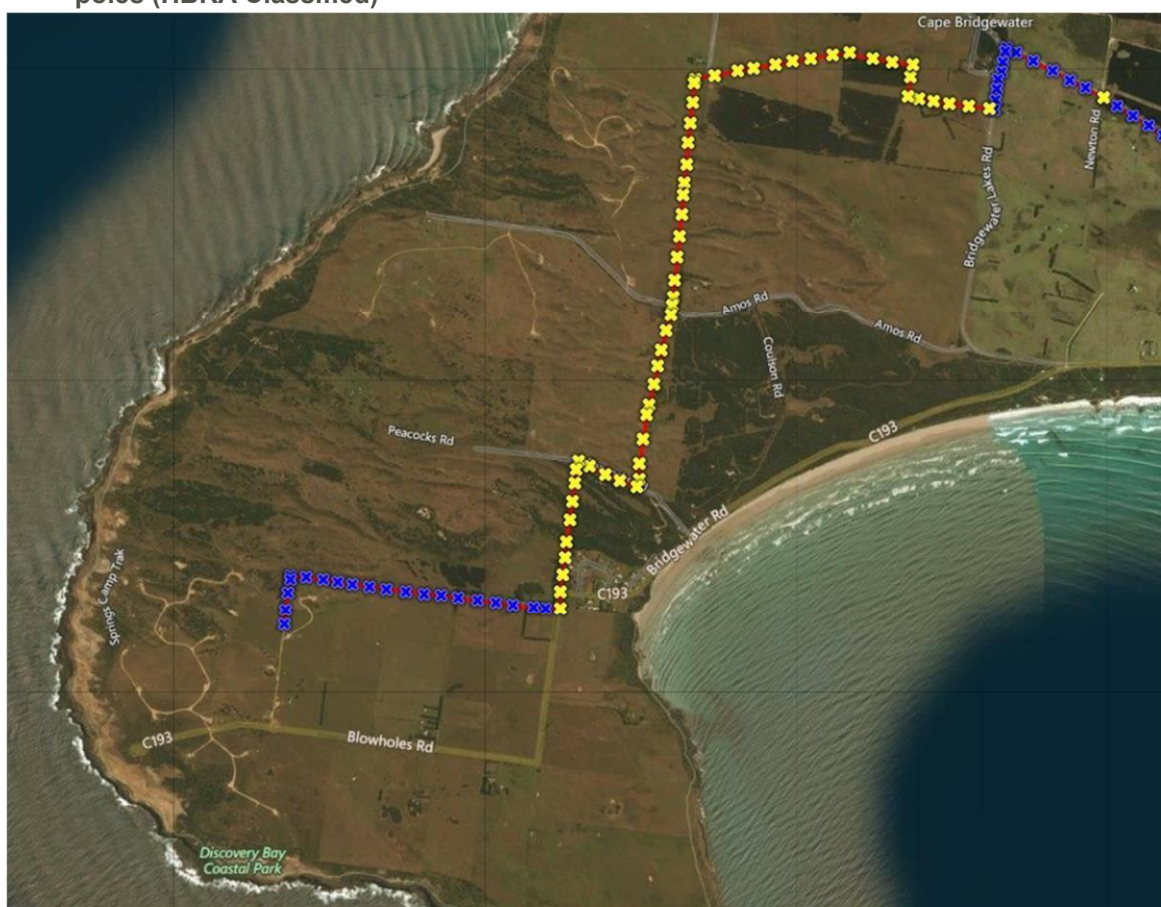
**Appendix A.2. Cape Bridgewater Site Layout showing the location of the electric lines and poles (HBRA Classified)**

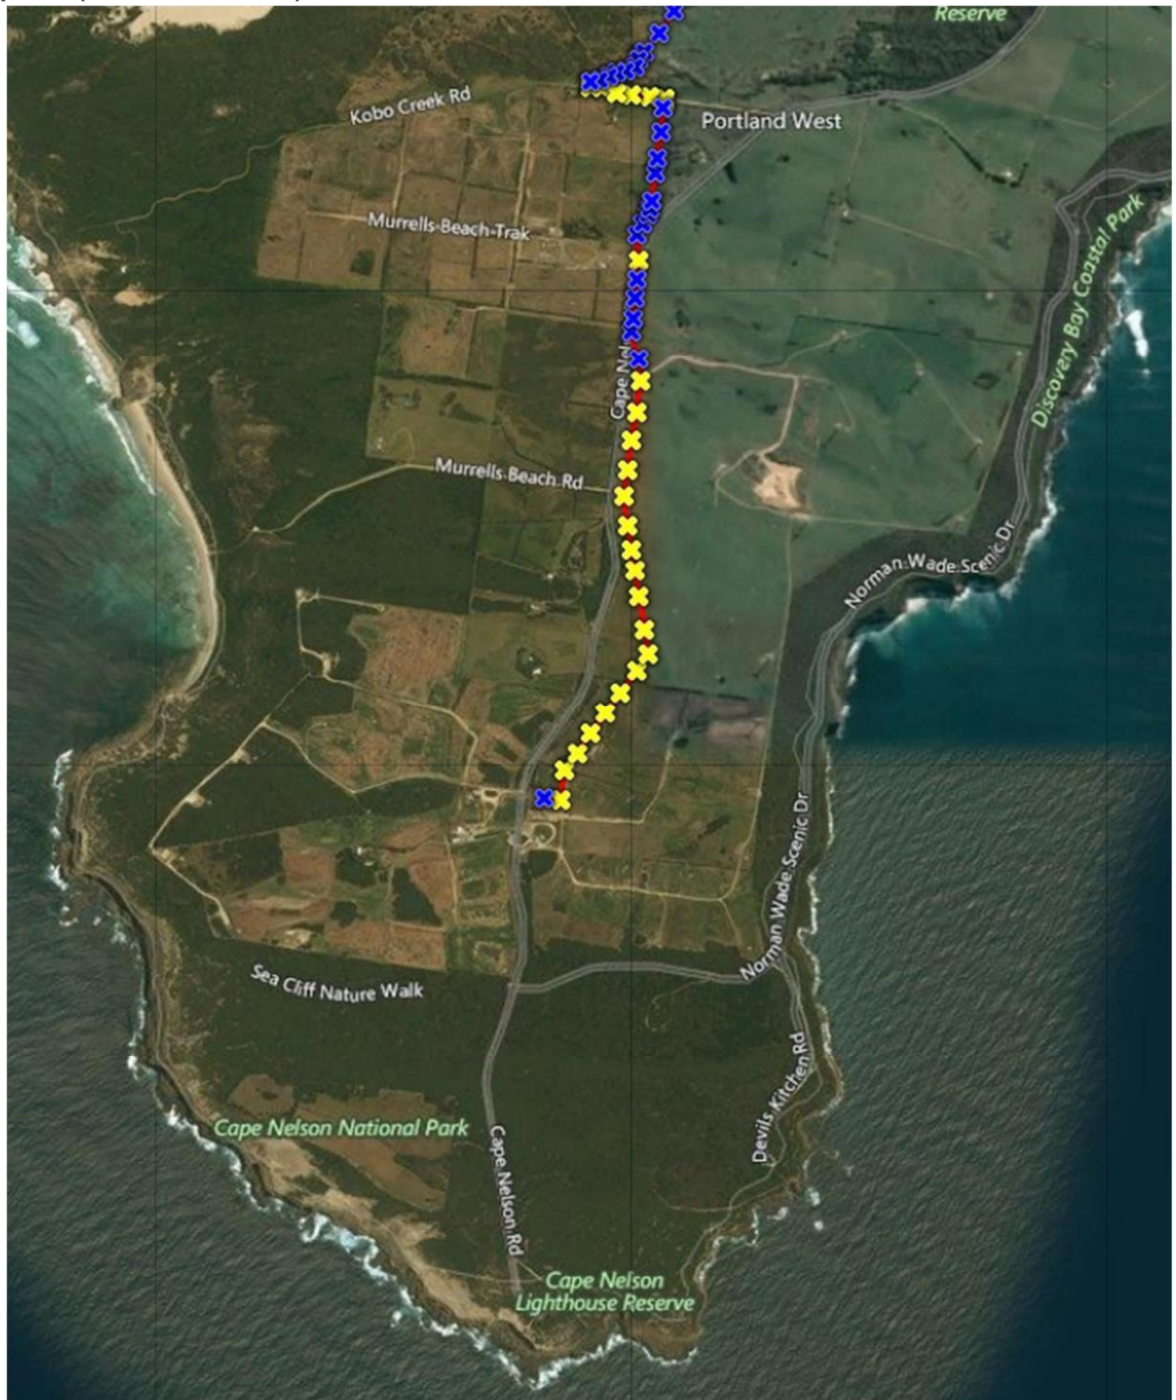
Appendix A.3 Cape Nelson South Site Layout showing the location of the electric lines and poles (HBRA Classified)

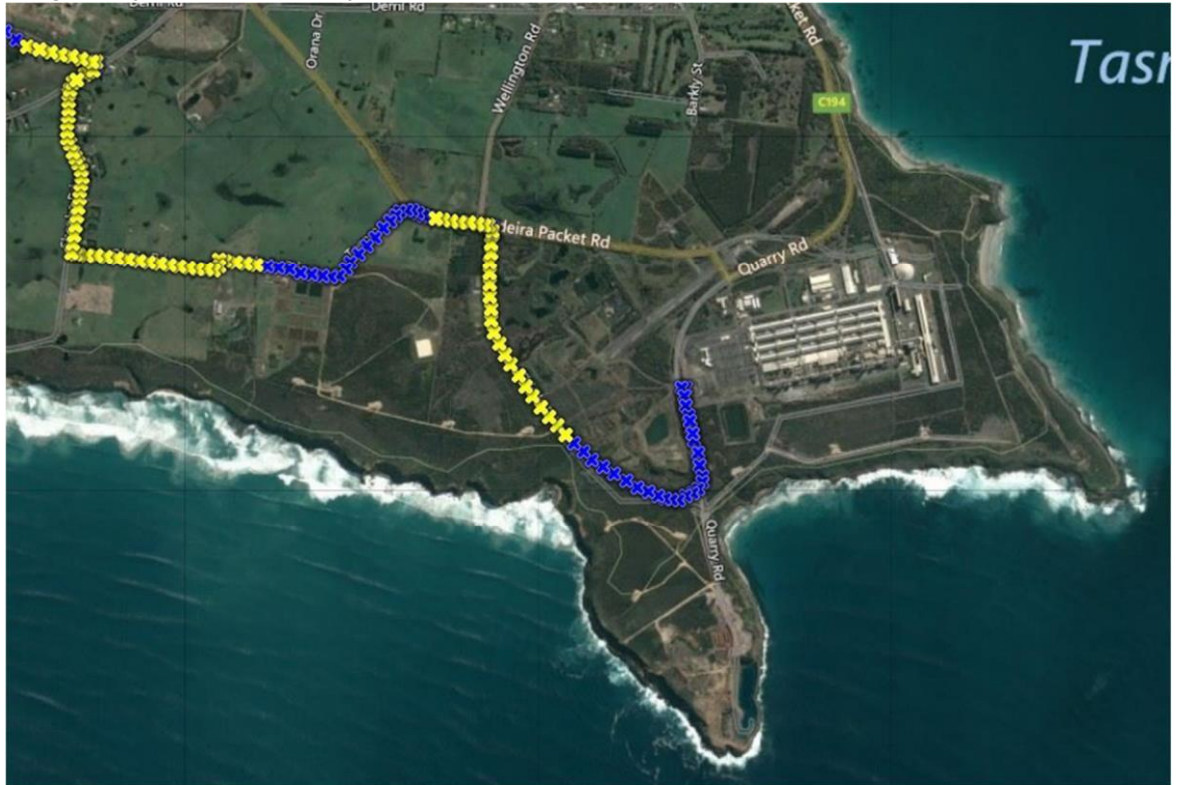
**Appendix A.5 Cape Sir William Grant Site Layout showing the location of the electric lines and poles (HBRA Classified)**

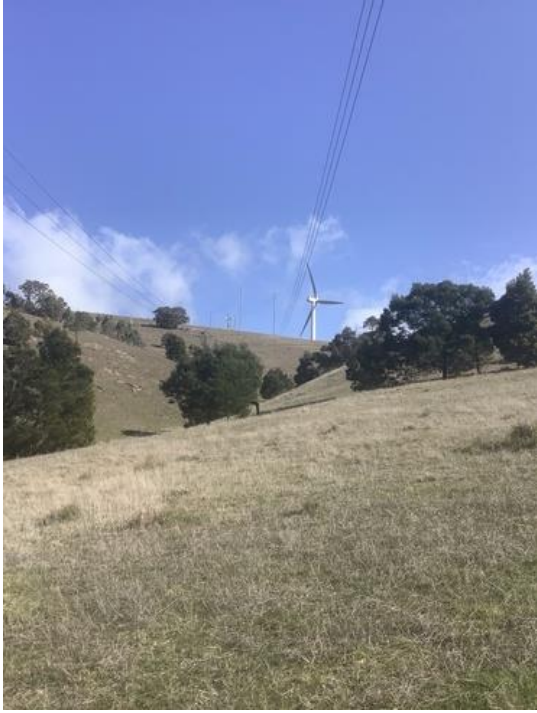
Photo 5	
Trims	
Removals	3
Species	Acacia
Equipment Required	Ground Crew
Comments	2025
